**SAS Superstructure**

**Daily Diary Report by Bid Item**

Contract No.: 04-0120F4

Diary #: 699 Const Calendar Day: 141 Date: 23-Oct-2012 Tuesday

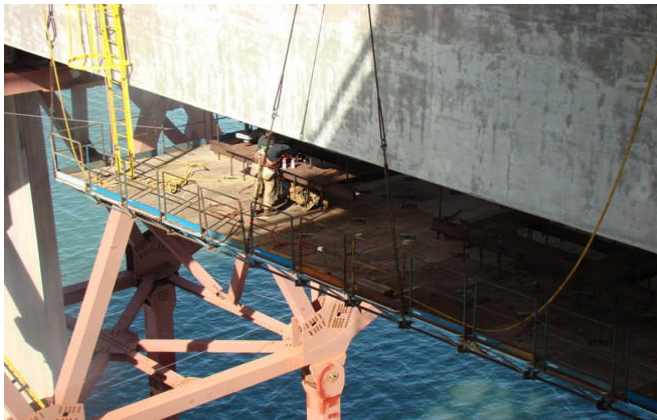
ABF ironworkers down below the S3 Shear Key pulling through the anchor rods that connect the shear key to the E2 cap beam.

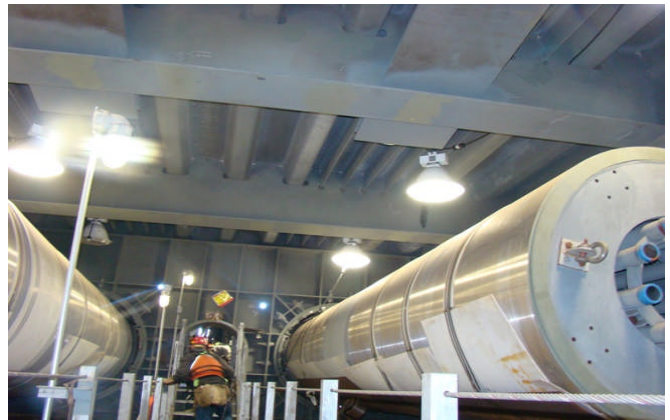
The Hinge A pipe beams seen from inside the E-Line Skyway steel tub section as pulling operations on this side of the bridge are in progress.

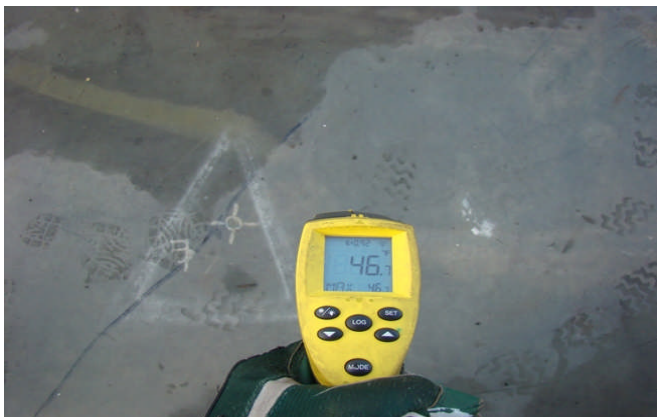
Steel temperature of 47 after the measurements were taken on the Skyway steel tub section near the seismic joint centerline.

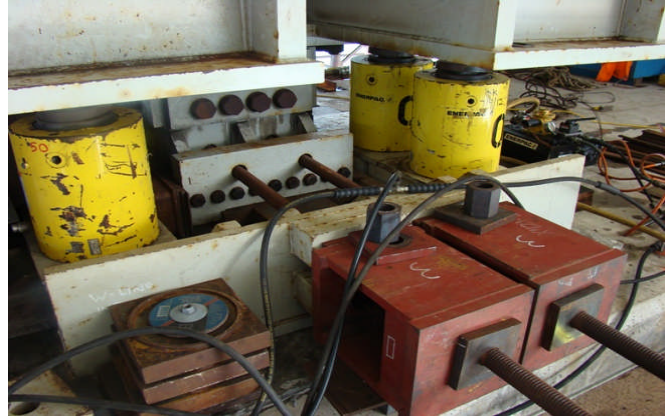
Jacking seen on a temporary bearing support in the longitudinal direction of the bridge.

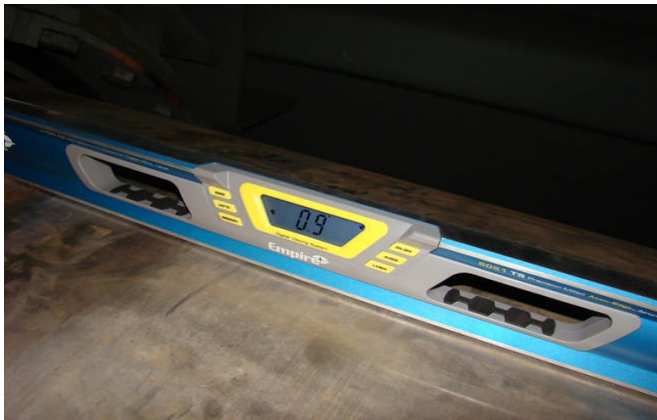
The smart level placed on the stainless steel section on the top dead center of the W-Line North pipe beam west of diaphragm C.

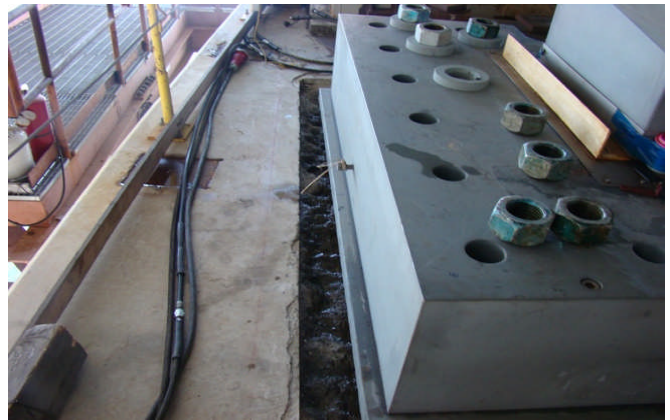
Skewed lower housing of Bearing B1 still needs to be rotated.

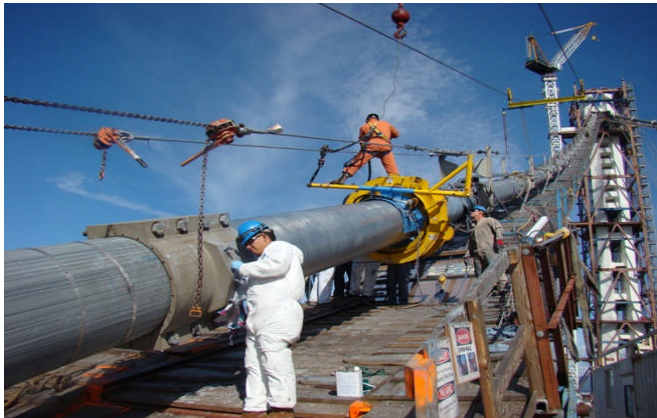
ABF ironworkers on the North Sidespan wrapping the main cable with S-wire.

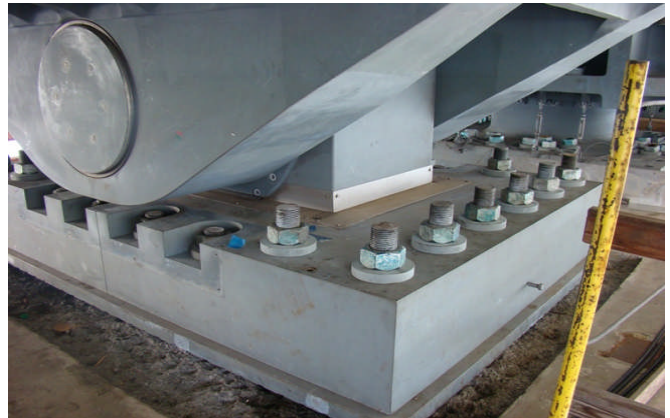
Anchor rods installed through the lower housing of the B2 bearing.
